TOE LOG CRIBBING

(LOW GRADIENT STRUCTURE)

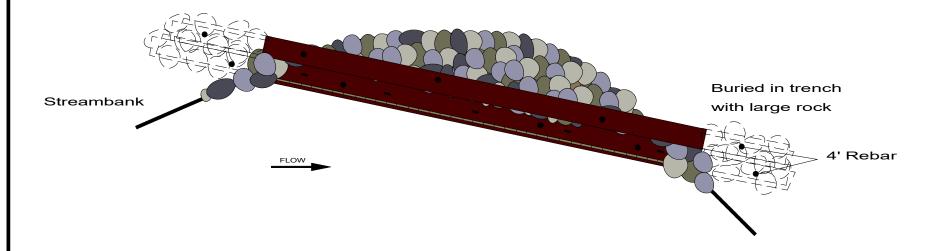
Plan View

Section View

Second Log (Optional)

Normal
Water Level

Stream Bottom

4' Rebar

Note: Recommended only for use in low gradient systems
