RESTORING SPRING CREEK

McCoy-Linn Dam Removal and Habitat Enhancement Project

**RESTORING
 SPRING CREEK**
 McCoy-Linn Dam Removal
 and Habitat Enhancement Project

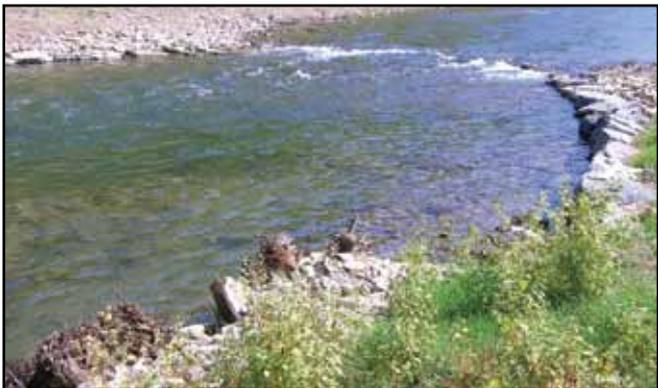
In-stream structure consisting of two rock arms connected in the middle by additional rock control the slope of the stream bottom and channel water to the center of the stream and away from stream banks.

In addition to the removal of the dam, the resulting stream channel was adjusted to appropriate dimensions, and in-stream habitat improvement structures were installed throughout the former impoundment to enhance fish habitat and stabilize the stream banks. Structures included multi-log vane deflectors, root wads, mudsills, rock vanes, rock cross vanes and boulder placements. These structures are all made of natural materials and are designed to blend into

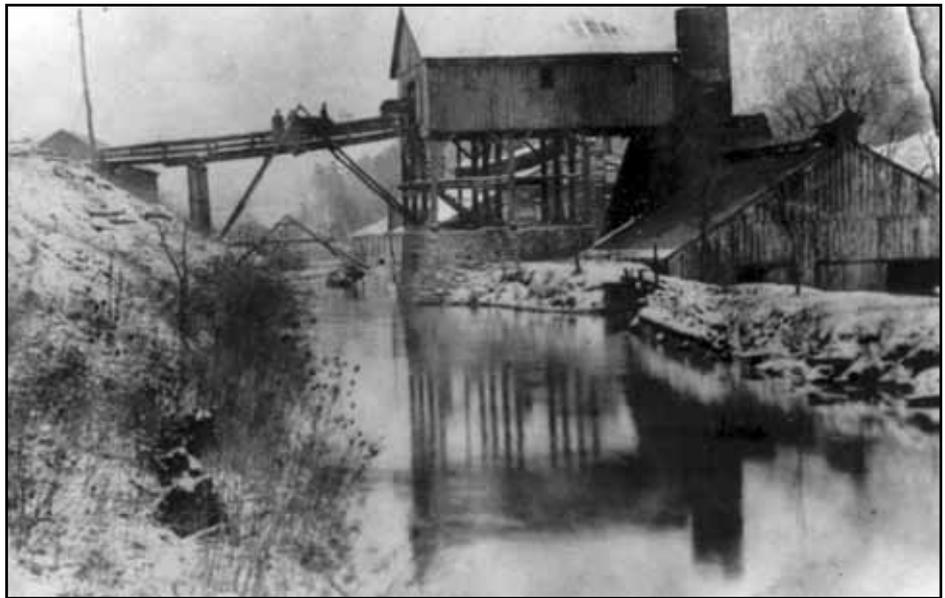
This is Milesburg Ironworks, probably in the 1870s. In this photo, the furnace stack and casting house is on the far side of the canal basin above lock no. 4 (which is out of the frame to the right) as well as the charging bridge that brought ore and fuel to the furnace top. The building in the foreground is the casting shed, and the canal basin spillway drains just in front of it. The second rolling mill, across the river, was built sometime before 1887.

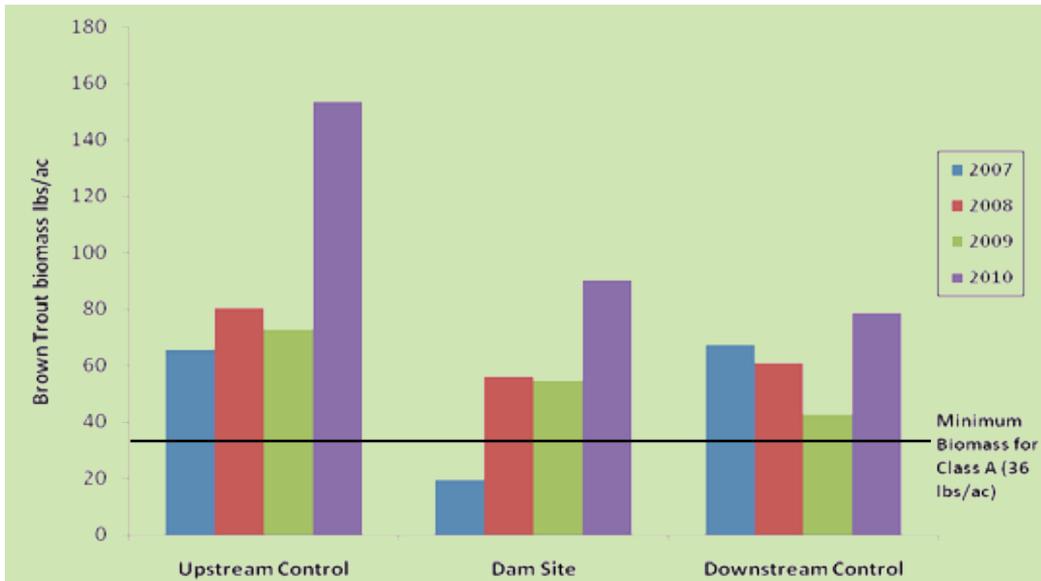
Figure 1. Brown trout biomass before (2007) and after (2008–2010) dam removal and habitat enhancement in the former impoundment and control reaches. Note: The biomass estimates are based on single-pass electrofishing data, not a population estimate, because only single-pass electrofishing was used when conducting the pre-dam removal survey in the former McCoy impoundment.

Fishery monitoring at the McCoy site from 2007-2010 showed a substantial improvement in the abundance (number) and biomass (weight) of brown trout inhabiting the study site before work in 2007 and after the dam removal in 2008-2010 (*Figure 1*). Control sites were also sampled to provide information on trends in the wild brown trout population at upstream and downstream locations where no habitat changes occurred. It is important to note that we also documented considerable increases in brown trout at the control sites from 2009 to 2010 (*Figure 1*).

Thus, the improvement at the McCoy site from 2009–2010 may be a function of an upward trend in the population as a whole, not just the improved habitat conditions. Additional fishery monitoring at these sites over the next few years will provide more insight into trends of the population. It is expected that the McCoy site will either maintain itself at the current high level or may even continue to increase over the next few years as the brown trout continue to take advantage of the improved conditions. Improving the wild brown trout population at the McCoy site was a major objective of the project.

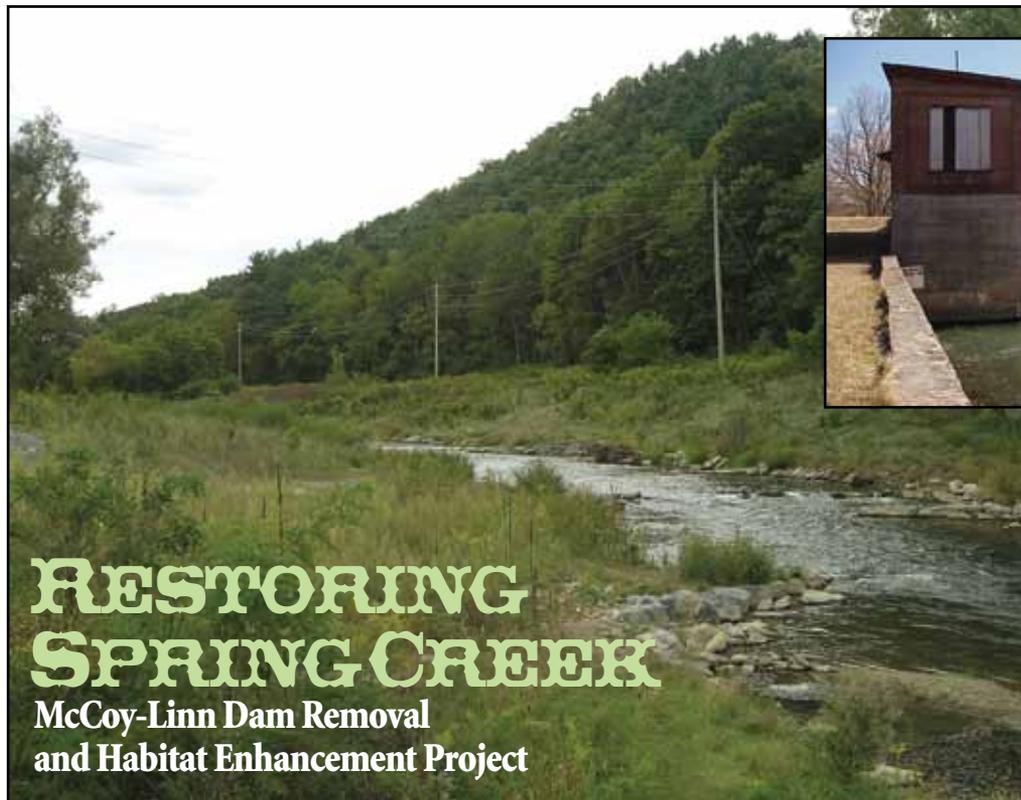
photo-Katie Ombalski
 McCoy-Linn Dam prior to the dam removal in 2007.

Since the late 1700s, the 12-foot high McCoy-Linn Dam impounded a half-mile of Spring Creek resulting in degraded habitat. While some dams are beneficial to society, many have exceeded their usefulness and continue to age and deteriorate. Dams change the physical, biological and chemical functions of streams and alter natural stream flow. They warm water temperature, trap sediment and prevent passage of fish and other aquatic life. Dams can also increase flood risks and threaten lives of anglers, boaters and swimmers.
